Smoke and Dye Testing Summary

High Level Sewershed

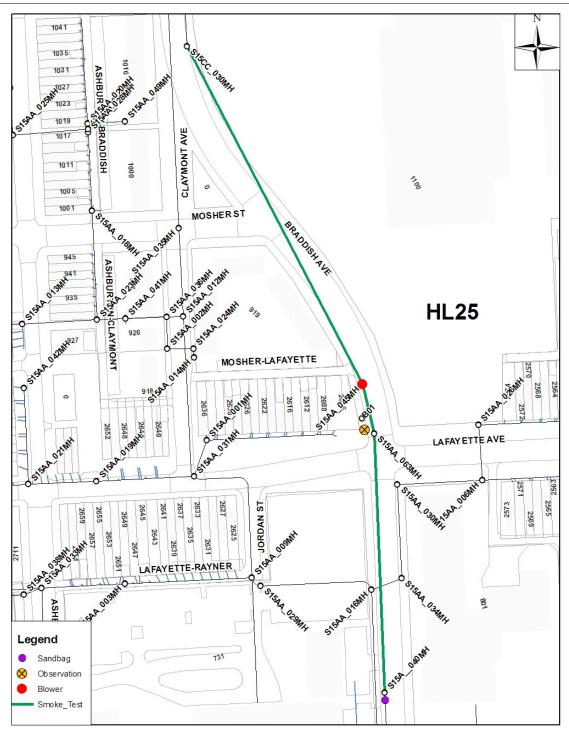
Picture \S1028-189-OB01-P01.jpg

Comments Smoke from catch basin on the northwest corner of Lafayette Ave & Braddish Ave

Comments Lafayette Ave & Braddish Ave

looking west
